Confidential Inspection Report

123 ABC Street
Anytown, CO 80227

Report #: SAMPLE REPORT
Date of Inspection: 03/19/2008
Client: JOE SAMPLE
Address Inspected: 123 ABC Street, Anytown, CO 80227

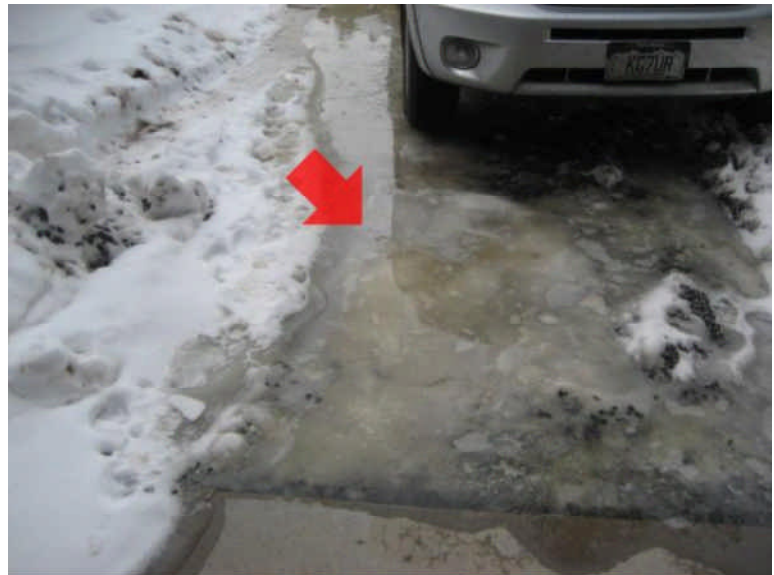
General condition appears serviceable. Ice build up seen. Not fully visible. Poor drainage. Pooling /ponding area sensed at, front of vehicle entry into garage.

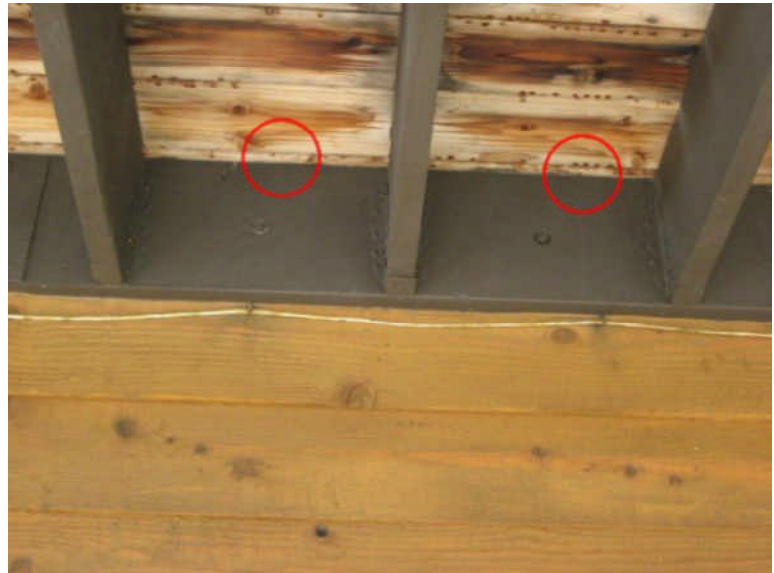
Deck Structure Condition:

General condition appears serviceable. Flashing appears to be missing at connection of deck to dwelling.

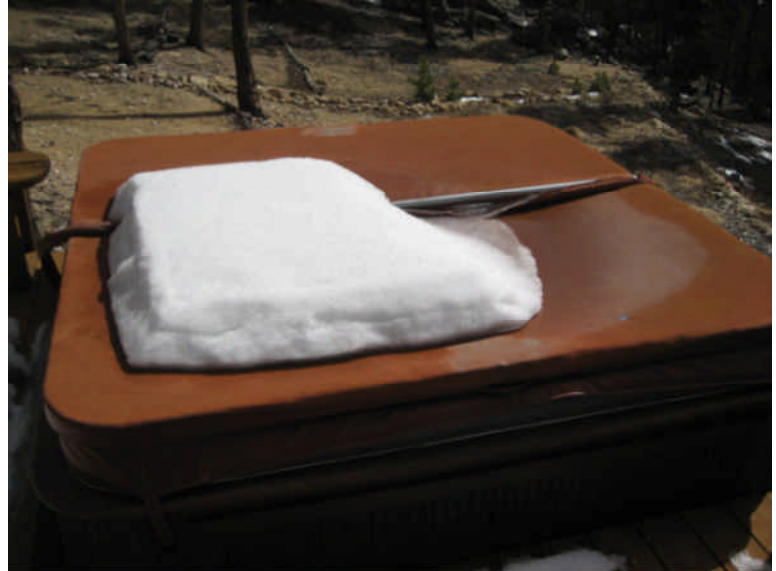
Deck Surface Condition

General condition appears serviceable. Hot tub seen not inspected. Surface not fully visible. Cover damaged, water logged, No water in the tub. Not operational. Tub should be filled with water and further evaluated by a professional. Repairs or replacement of components may be necessary.

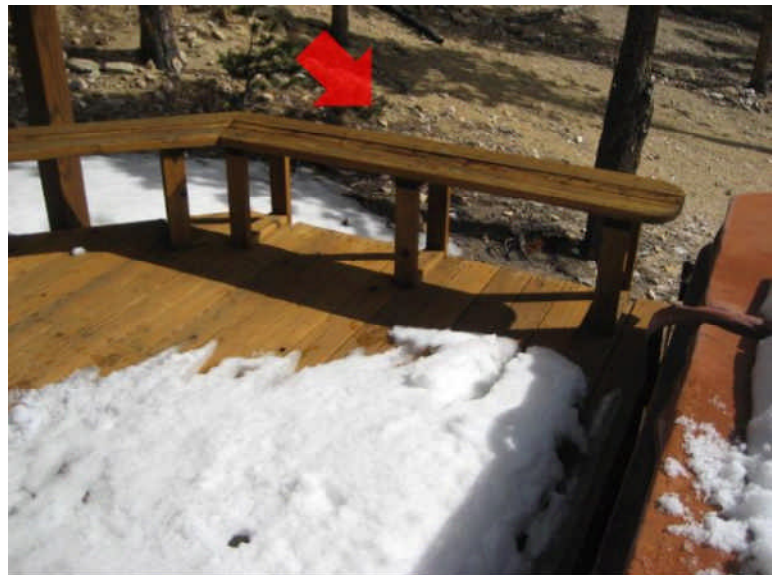
Deck Railing Condition

General condition appears serviceable. Unprotected openings at railing of deck. Bench seat seen where no back support seen. Fall hazard sensed.

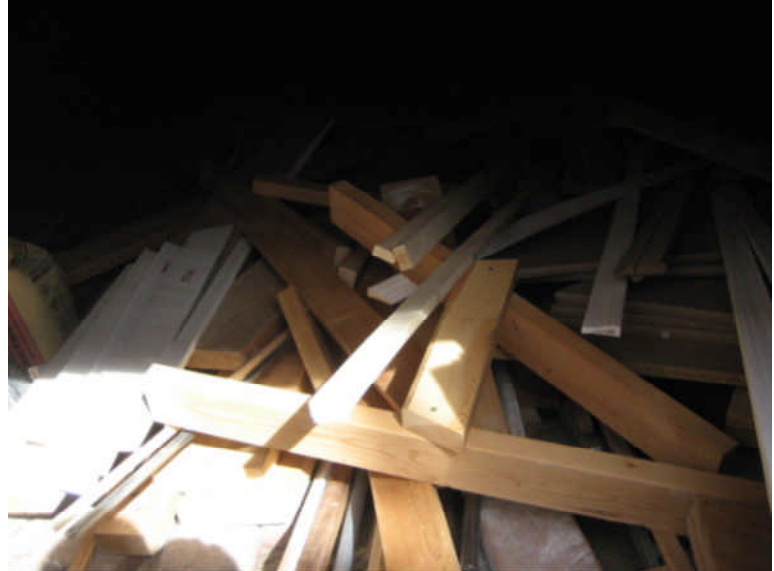
Access issues present at time of inspection. Debris seen in setting prohibits full visibility. Owner's stored contents were present in the crawlspace setting. They prohibited full access to view and inspect. The crawlspace was inspected from the access way due to conditions that were unfavorable to the inspector.

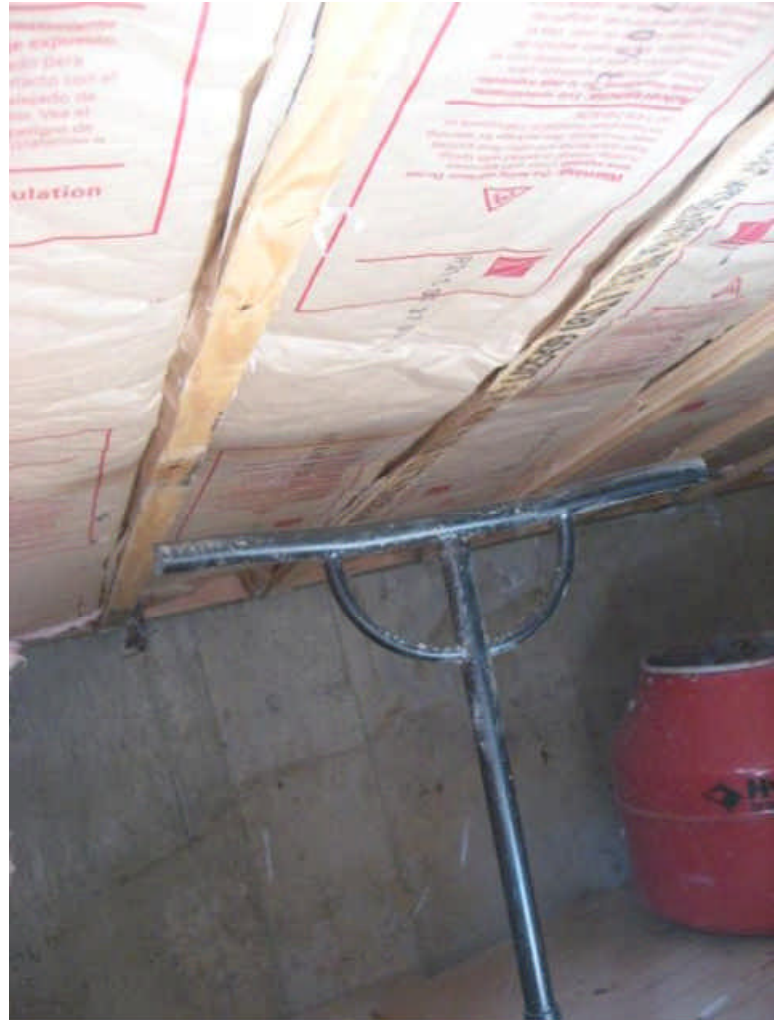
General condition appears serviceable. We sensed the insulation to be installed backwards. Paper facing was exposed. The exposed paper commonly is placed up against the area to be heated. Exposed paper facing seen on the insulation material. The paper facing can burn.

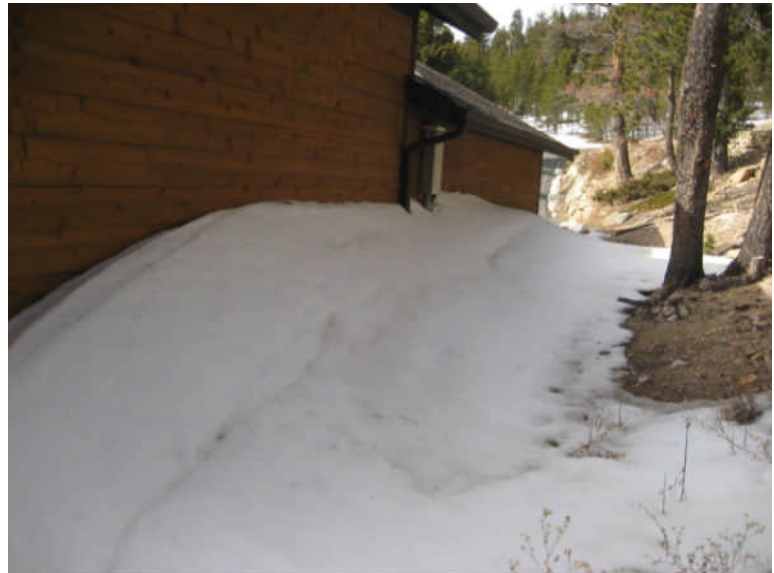
Unable to fully view due to snow cover.

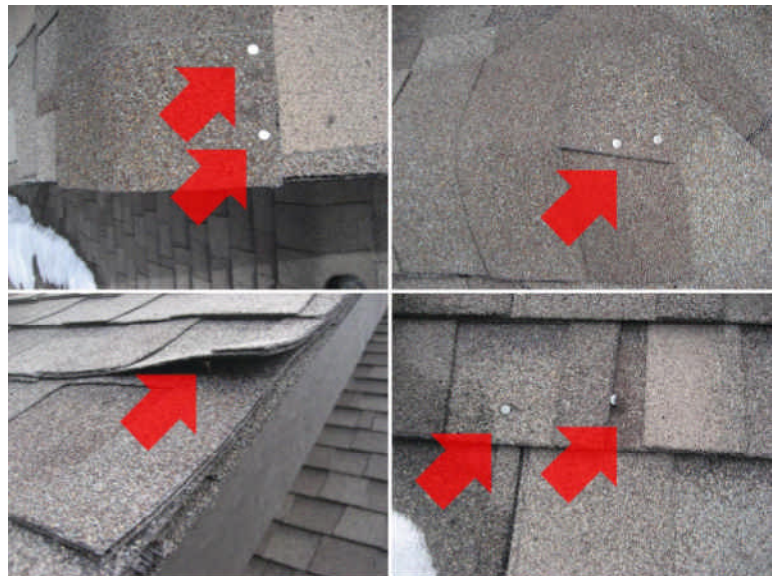
Seal exposed fasteners to make more weather tight. Fasteners seen backed out.

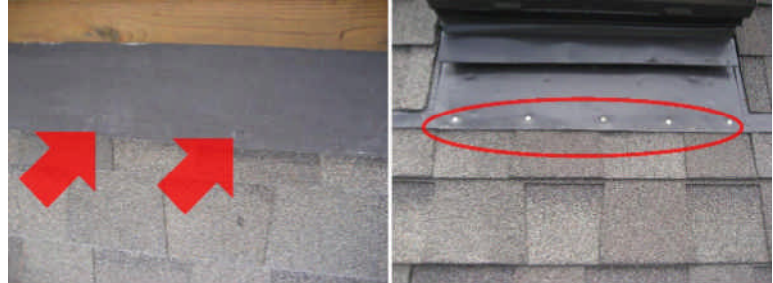
Flashing Condition

General condition of the accessible and visible areas appears serviceable. Flashing nailed through and the nail head not sealed.

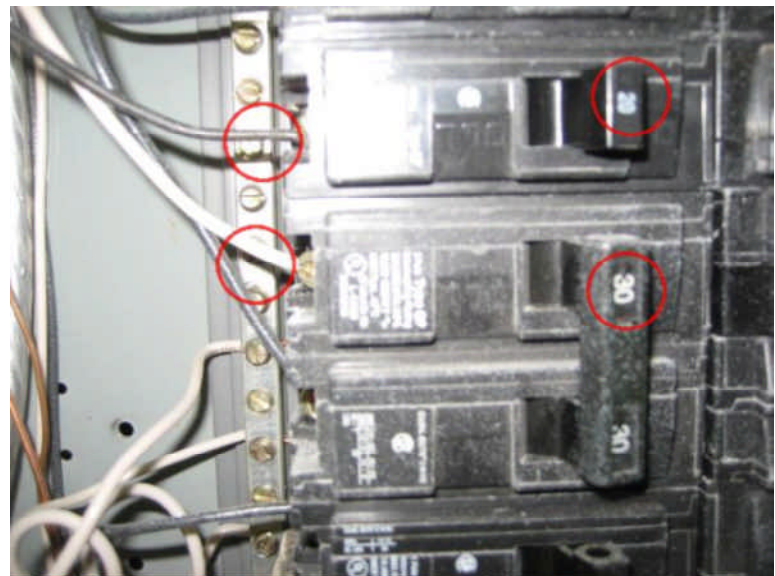
General condition appears serviceable. We do not test standard circuit breakers inside the panel box to test their operation. Over fusing seen. The breaker is too big in relation to the wire size connected into the breaker, 30 Amp breaker seen. wiring rated for 20 amps, 15 amp wire sensed connected to a 20 amp breaker.

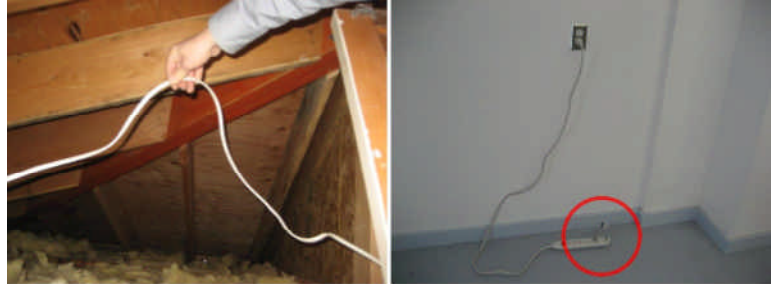
Wiring Conditions

General condition appears serviceable. Wiring cables exposed and unprotected. Attic. Extension cords installed as permanent wiring. We recommend they be replaced with safer, permanent wiring of an appropriate type for the application. Location: Garage.

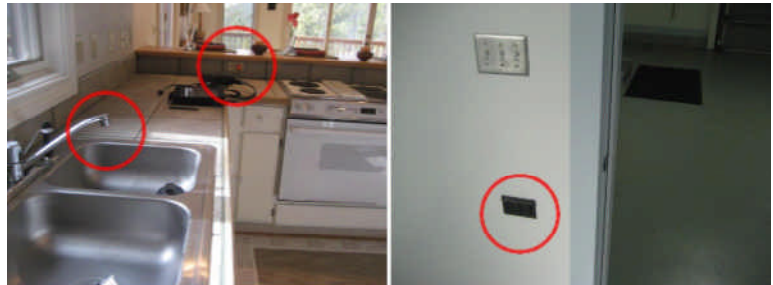
Ground Fault Circuit Breakers (GFCI)
Condition

A GFCI receptacle was operated using a testing device and found to remain energized when the device is tripped. The receptacle does not have GFCI protection. Kitchen. One reception see in craft room behind garage is not protection.

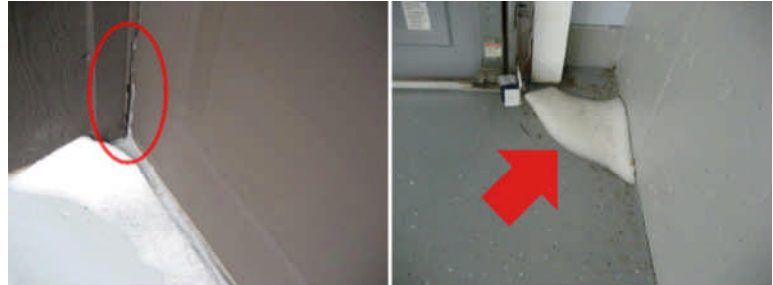
General condition appears serviceable. The vehicle door when closed doesn't create a complete seal at the floor. Damage was seen to the weather stripping. Replacement may be required. Moisture and vermin may be able to gain entry into the garage area. Snow seen entering here.

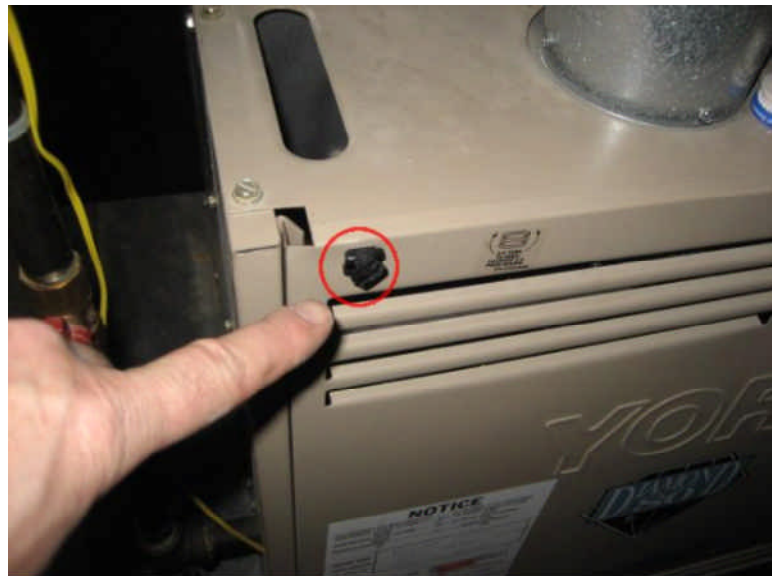
Heating System Condition

General condition appears serviceable. Common wear seen. Unit's access cover has broken locking clips which now doesn't keep the door fully secured as designed.

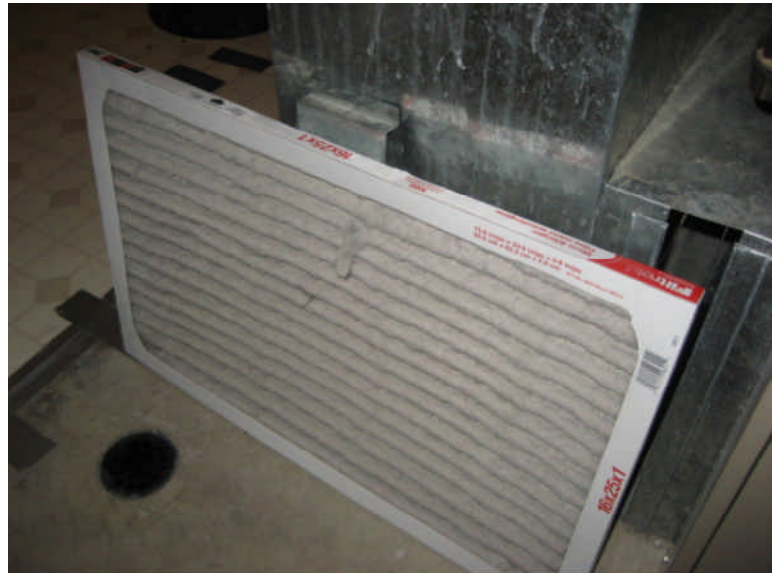
Filter very dirty and is in need of cleaning or replacement now.

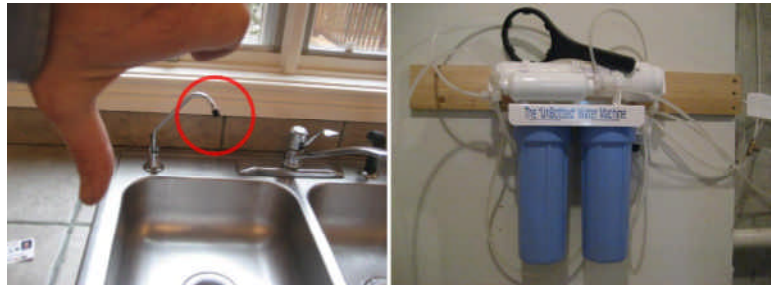
A water filter system is installed. We did not inspect the system or components. It is considered beyond the scope of our work. A pressure tank system is present. It was not fully inspected. Viewing the internal condition of the tank is not possible. The expected lifespan of the tank was not determined. Not inspected, Not fully visible. Drinking water device seen didn't produce water when operated. Consult seller or a qualified professional familiar with water filtration to further evaluate the system.

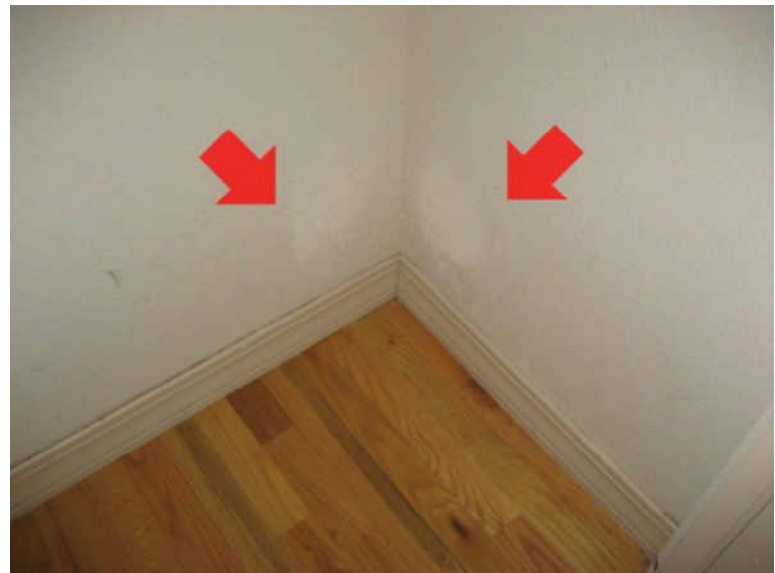
General condition appears serviceable. Common wear seen. Common cracks were seen. Repairs seen or sensed Main level NW bedroom. Foyer closet.

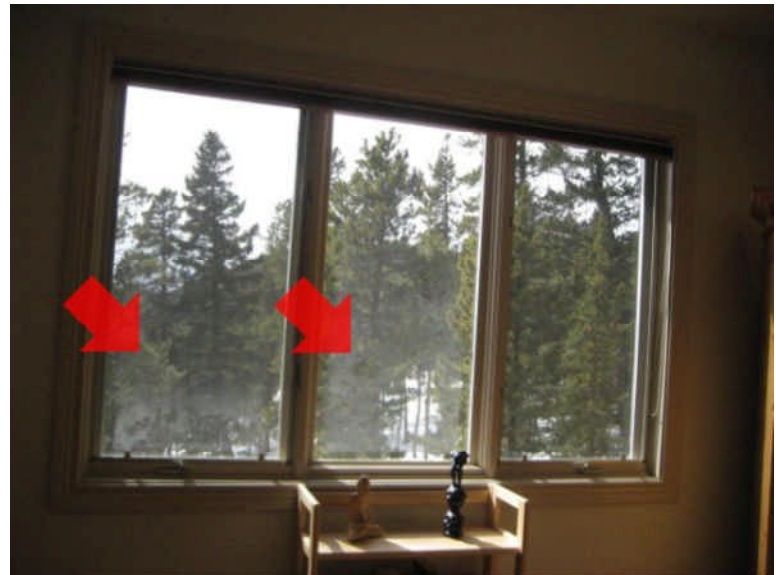
General condition appears serviceable. Common wear seen. Double pane glass appears to have lost its seal. Condensation or staining was seen between the glass. Main level SW bedroom.

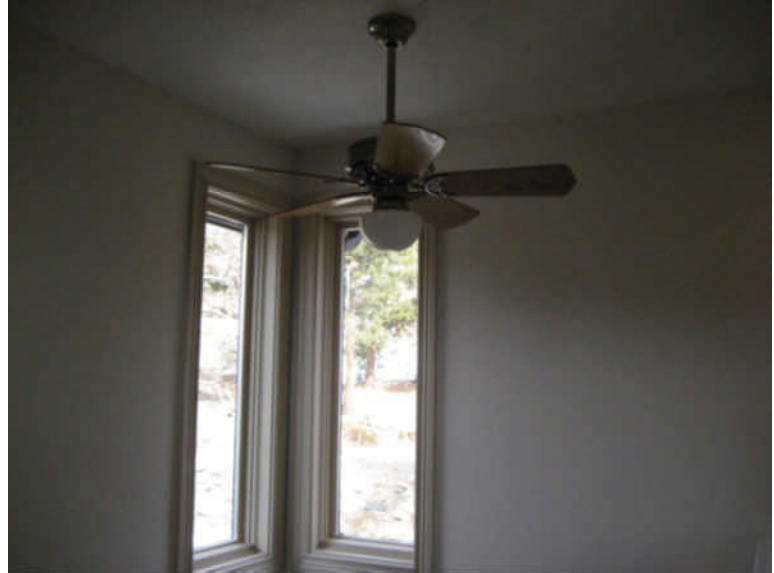
Ceiling Fan Condition

General condition appears serviceable. Fan does not respond to normal operating controls. Landing to upper level.

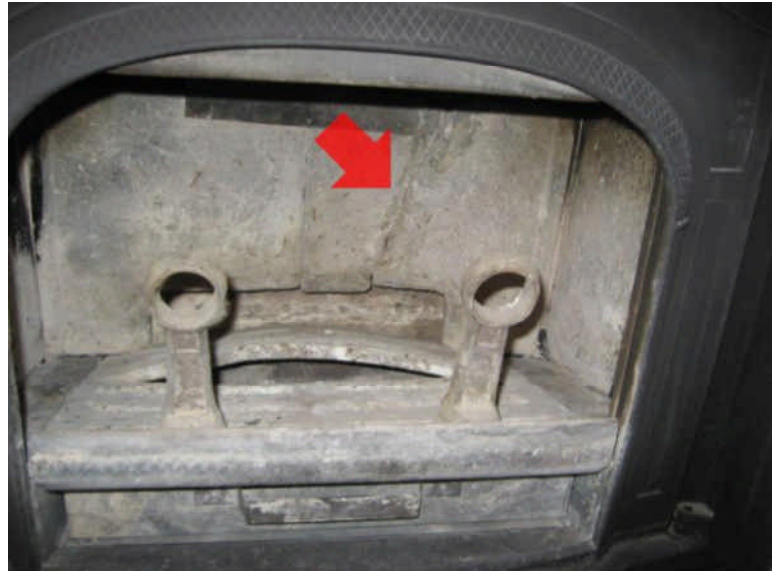
Firebox Condition:

General condition appears serviceable. Firebrick inside the firebox damaged. Gasket is damaged. Common cleaning recommended now.

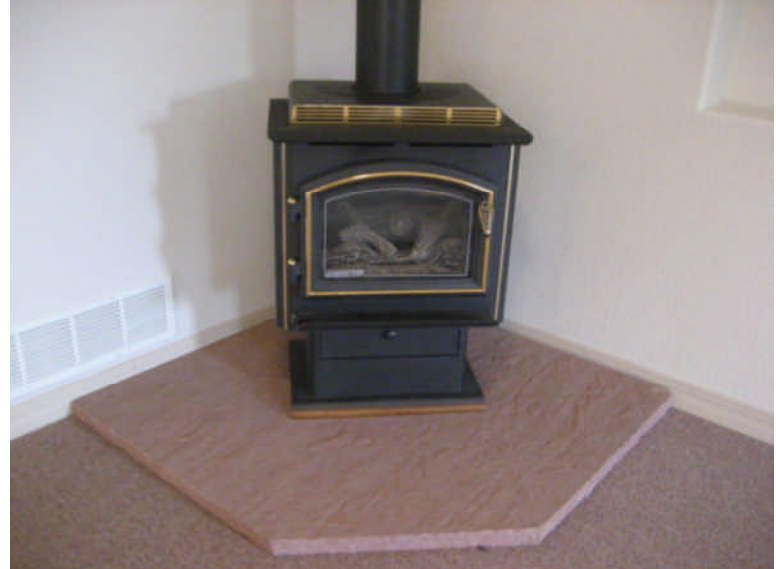
No Fire was present in burn basin at time of inspection. Flame or ignition not created by inspector. It is beyond the scope of our inspection. Normal /simple controls did not create fire at the unit. Contact a professional to further evaluate and confirm unit is operational and safe before you operate it.

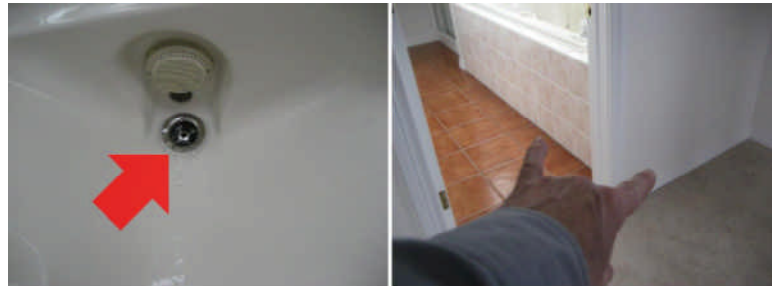
Jetted Tub

Jetted tub seen not tested. No drain stopper present in tub at time of inspection. Have the stopper installed and test the jetted tub. Access to the service the internal components of the jetted tub appears improper. There was not visible access panel present at the jetted tub to access and service the pump and the motor.

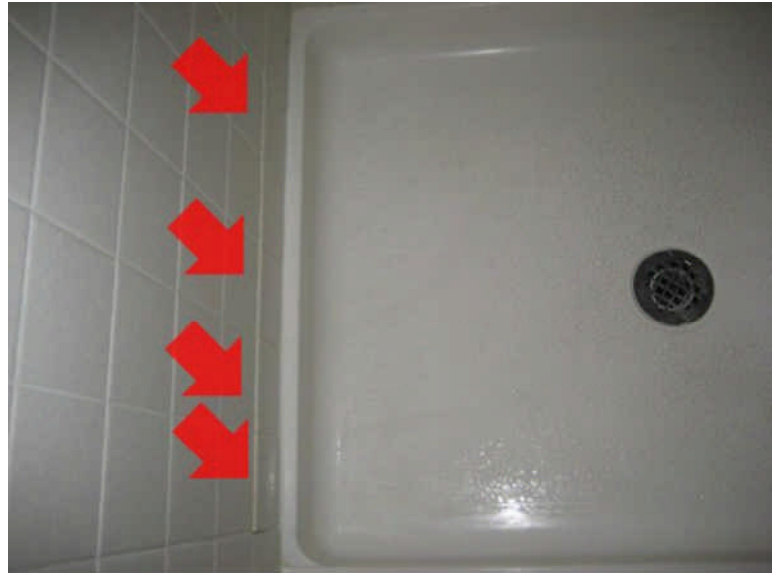
General condition appears serviceable. Setting is integrated above the bathtub or pan. Tile at wall loose. Repairs recommended.
