Confidential Inspection Report

123 ABC Street
Anytown, CO 80227

Report #: SAMPLE REPORT
Date of Inspection: 03/19/2008
Client: JOE SAMPLE
Address Inspected: 123 ABC Street, Anytown, CO 80227

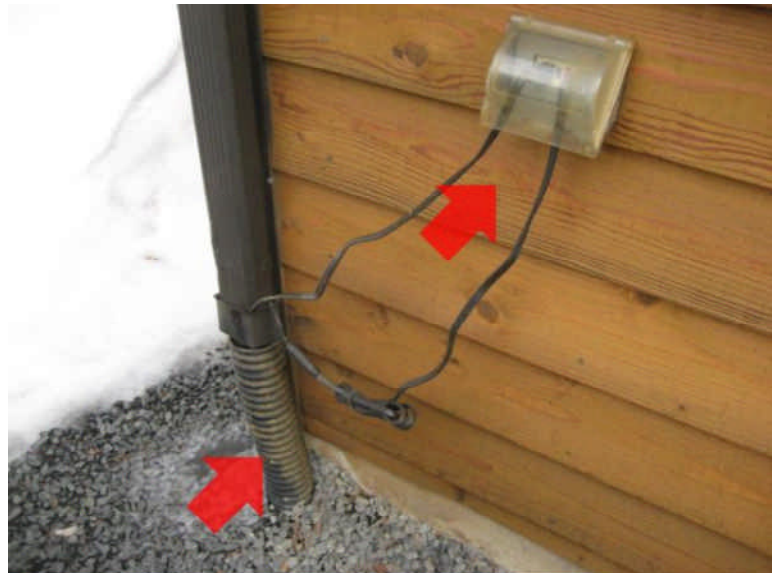
Roof Gutter System Material
Roof Gutter System Location
Roof Gutter System Material Condition

Metal like.
Full guttering installed.

General condition appears serviceable. We can not assure you of its actual performance now or in the future. Water testing of the gutter system was not performed as this is beyond the scope of our inspection. Blockage issues. Gutter filled with tree leaves or needles. Not fully visible. "Heat tape" applied in the troughs of the gutters. Tape was seen plugged into an outlet and appears to be serviceable. Ask seller for history. The downspouts enter the ground and are not visible from this point onward. We were unable to determine where they empty and if they are functional.

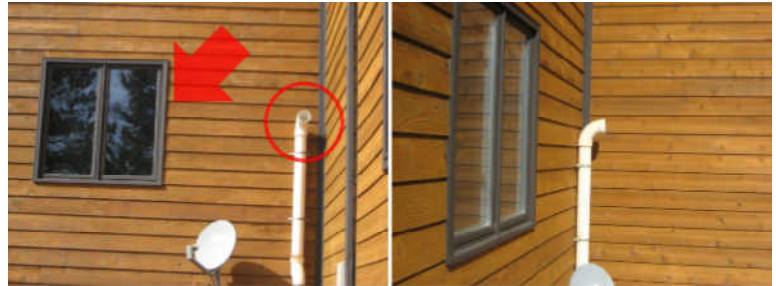
Radon Mitigation System

Radon mitigation system seen installed. The system is not part of this inspection and report. Radon testing is available for an additional fee. Contact us should you have questions about radon gas, testing, etc.
